HISTORIC RESOURCE SURVEY FORM
University of Oregon Cultural Resources Survey
Eugene, Lane County, Oregon
Summer 2006

Current building name: Collier House

Building address: 1170 East 13th Ave.

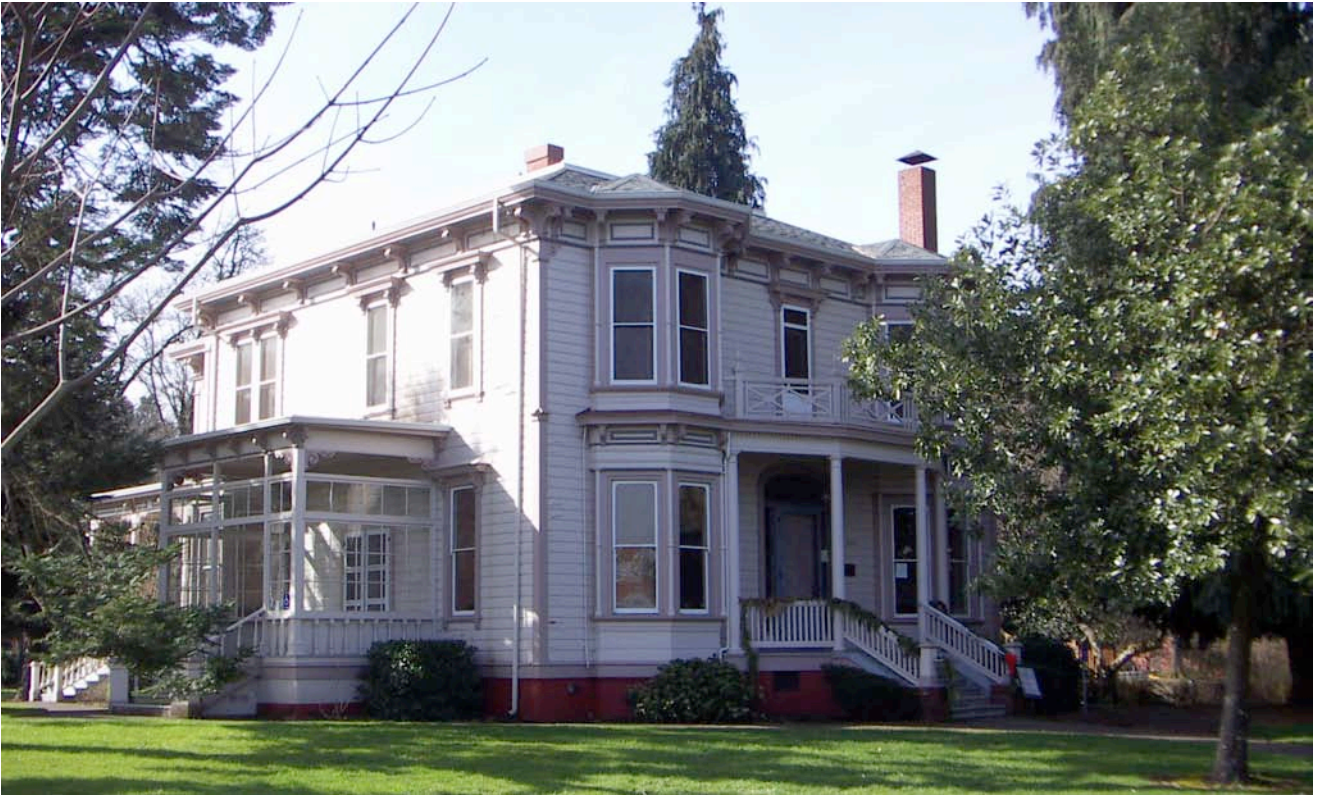
PHOTOGRAPH

Comments: This Italianate house has extensive decorative features, including wood fretwork balcony railing, round columns with capitals and entablature with dental course, porch balustrade (enclosed at portion of the east porch), second story bracketed window crowns, leaded fanlight and sidelights surround front door, decorative eave brackets on main house and small eave brackets on dining room addition. The accessible ramp/porch addition on the west facade is a simple, reversible, wood structure with slatted railing and lattice work.
